MTL-TR 87-50

HYDROGEN INDUCED CRACKS IN ARMOR STEEL WELDMENTS FABRICATED WITH AUSTENITIC FILLER ALLOYS

WILLIAM S. RICCI

September 1987

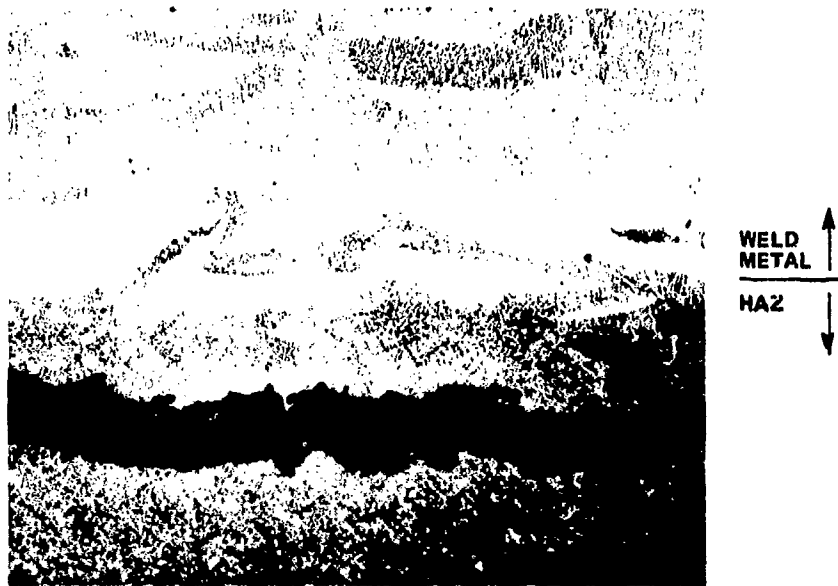
Typically, cracks in armor weldments fabricated with austenitic electrodes are found in the weld metal oriented transverse to the weld axis. Similarly, hydrogen induced cracks in armor weldments fabricated with ferritic filler materials are typically found in the HAZ parallel to the weld axis, Figure 1.^{*} Cracks in armor weldments fabricated with austenitic electrodes, located in the weld metal but oriented parallel to the weld axis and away from the weld centerline, have not, however, been previously documented.

Figure 1. Hydrogen induced crack located in the HAZ of an armor steel weldment (150X).

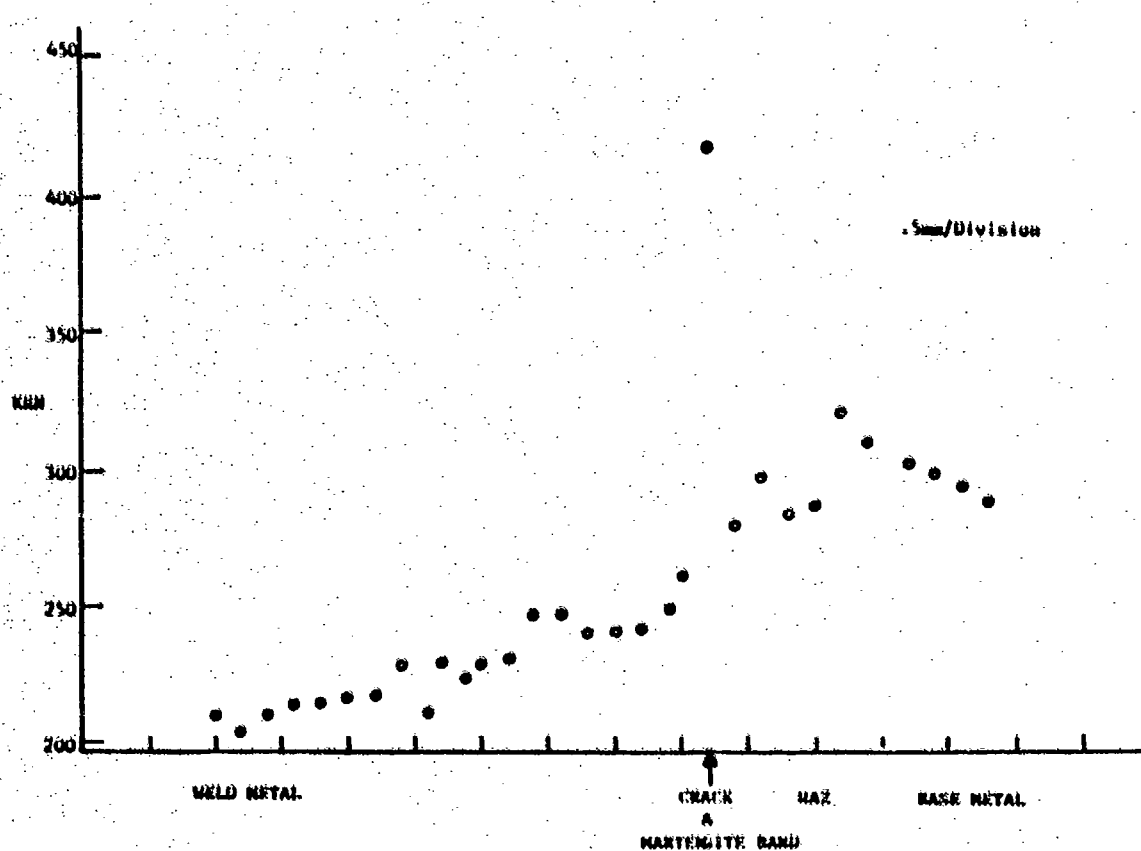
A hardness traverse was taken across weld fusion boundaries. Knoop hardness data were taken through the weld metal, the fusion boundary, the HAZ, and into the unaffected base metal. This data is presented in Figure 8. The martensitic phase through which the cracks propagated had a hardness of approximately 420 KHN, which is significantly higher than that of the weld metal (225 KHN), HAZ (320 KHN) and unaffected base metal (280 KHN).

Figure 8. Hardness traverse taken across the weld fusion boundary.

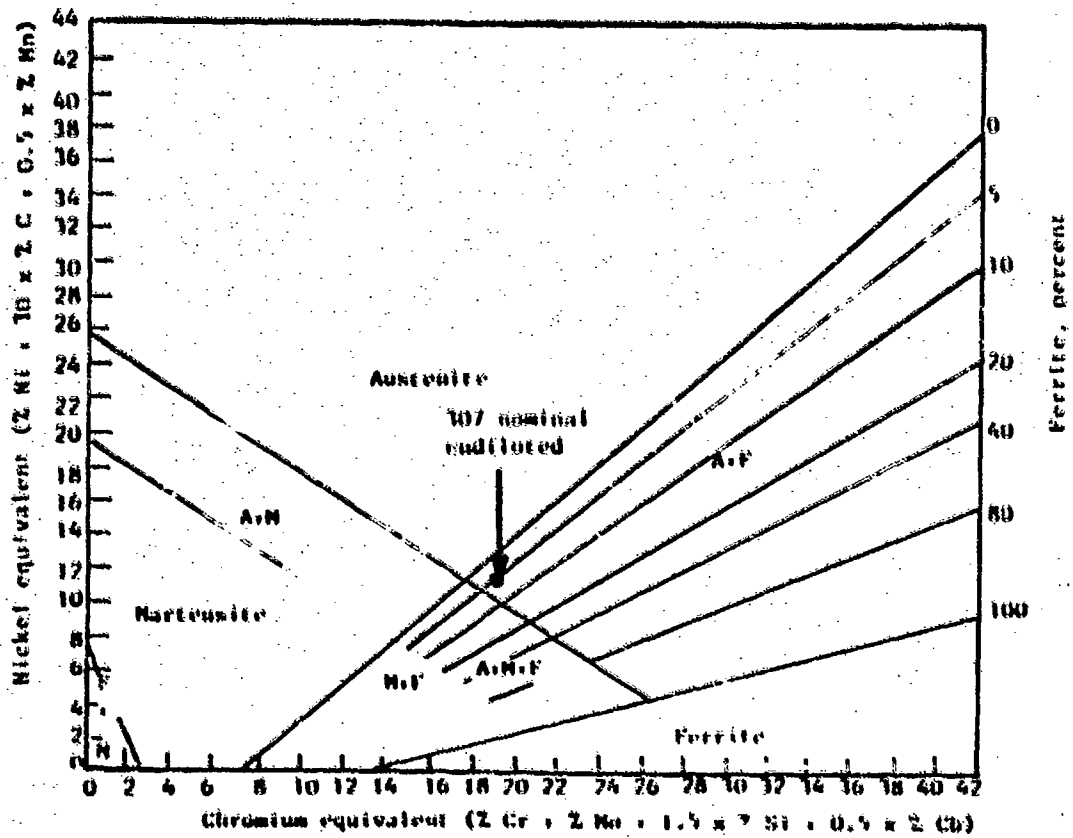
The Schaeffler diagram (Figure 10) can provide a first approximation of the effect of base metal dilution on martensite formation. For the alloy systems of interest here, only 17% dilution of the filler alloy with the base metal will result in the formation of martensite. It should be recognized that 40% dilution is often encountered under ordinary welding conditions, especially in the root pass. One alternative in resolving this problem, therefore, would be the use of higher alloy filler metals such as 309, 310 or 312 that can tolerate more dilution because of their more stable duplex austenite-ferrite structure. For example, 312 weld metals can tolerate approximately 45% dilution without forming martensite. The use of these alloys in other than high dilution passes (such as the root and buttering passes) is not recommended, however, since high ferrite contents reduce the ductility of the duplex structure.

Figure 10. Schaeffler diagram for estimating the microstructure of stainless steel weld metal.

The elimination of martensite is not the only method of deterring HIC in austenitic weld deposits. It is often more economical to reduce HIC susceptibility by reducing the available hydrogen concentration in the welding arc. This reduction can usually be attained by using electrodes with low moisture contents, and is generally considered to be the preferred alternative.
